Full-scale downburst damage versus boundary layer wind tunnel pressures: a survey analysis

Figure 1. Examples of damages occurred during the Porto Alegre January 29, 2016, downburst event.

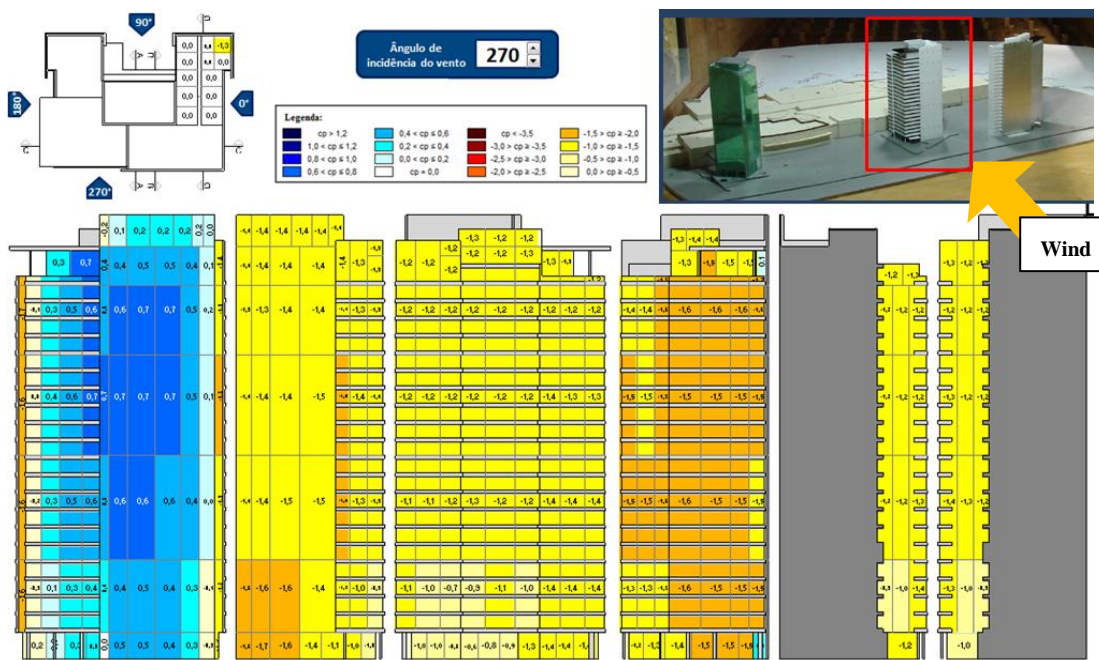
Figure 7. Mean pressure coefficient diagrams on buildings façades from boundary layer wind tunnel tests (suction = red, yellow; pressure = blue) for the central building indicated

All models were instrumented with pressure taps and instantaneous pressure measurements were taken over all model surfaces. Fig. 7 shows the mean pressure coefficient distribution for one of the buildings, and incidence angle of wind. Due to space limitations, the pressure coefficient distributions for other buildings are shown in the next section, together with the damage configurations.

For the group of buildings, the performance was different. All of them presented damage to their façades (Figs. 11 to 13), but in very distinct patterns. For the first group of three buildings shown in Fig. 11, for which some pressure coefficients diagrams are shown in Fig. 7, the evidence shows that the windows that were kept closed and locked did not suffer any damage, while some of those which were open, or even closed but not locked, were ripped out or broken by the wind action.

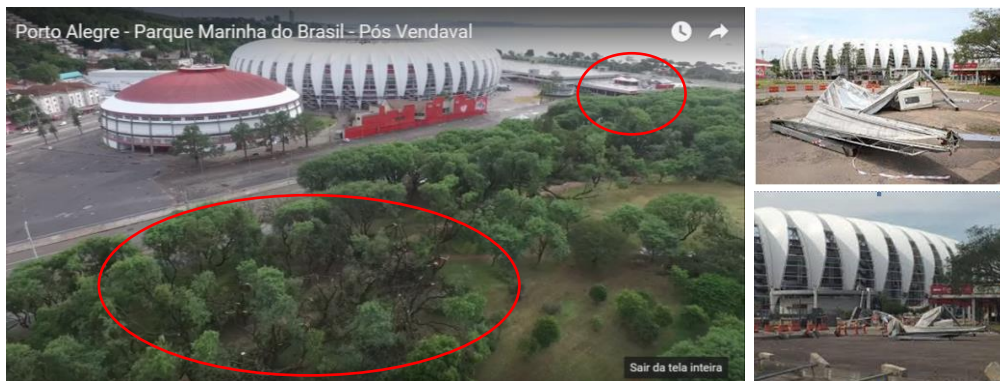
Analysing the performance of the structures, it is possible to verify that the stadiums remained undamaged, while the trees and surrounding structures were seriously damaged as can be seen in Fig. 10. During the design stage, modifications and improvements were made to the stadium structures due to the wind tunnel tests results.

Figure 10. Full-scale damage to surroundings caused by downburst and no damage to stadium

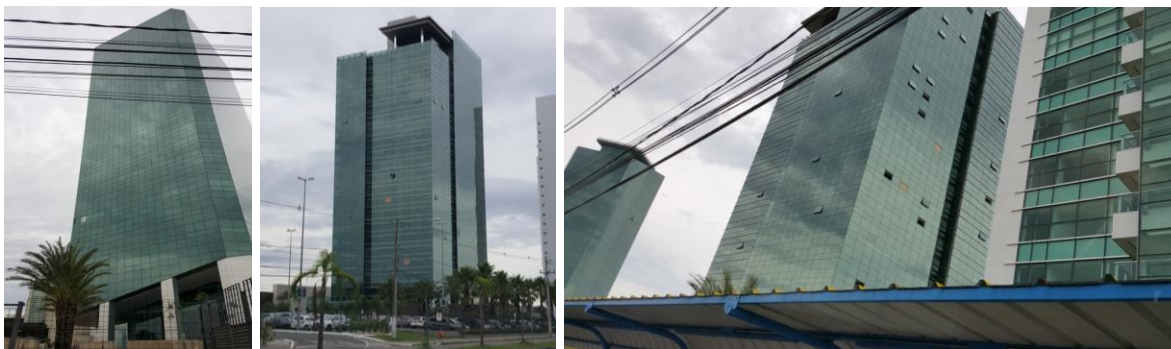
Figure 11. Full-scale damage to cladding elements: some windows that were not locked were destroyed

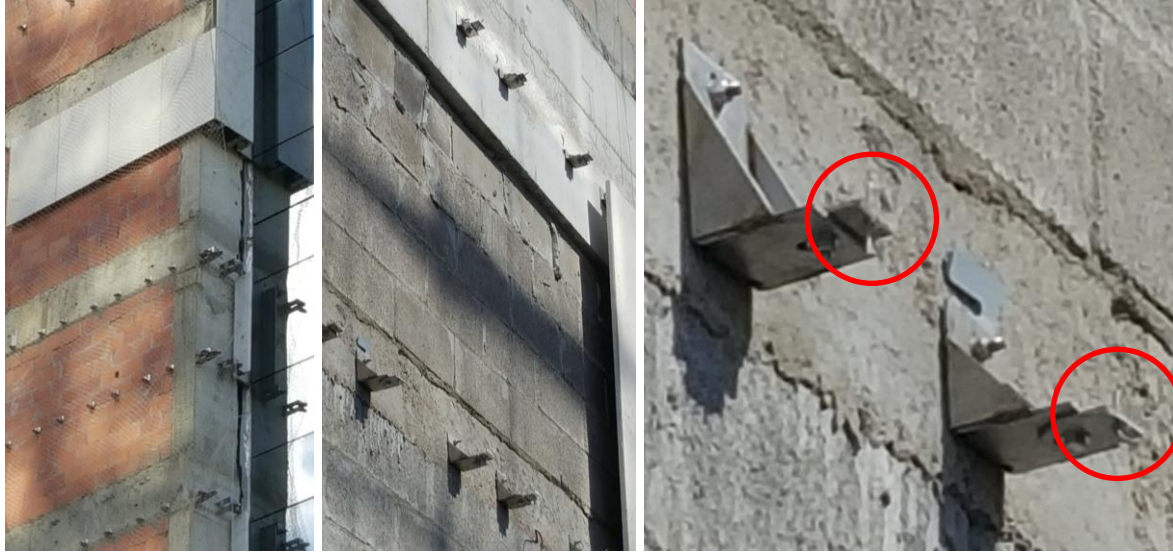
For Fig. 13 the correspondence between pressure distribution and damage to the granite cladding is very evident. The granite plate supporting system, shown in Fig. 14, does not seem to be designed to withstand wind pressures from the magnitude reached in the event, remembering that the design wind code velocity was not reached. Regarding the glass cladding, some damage occurred, but in a much smaller amount, being some ripped out when left open or broken due to the impact with windborne debris.

Figure 14. Full-scale damage caused by downburst and granite plate supporting system

In three of the most affected buildings (Figs. 12 and 13) the façades had two types of cladding elements: glass and granite plates. It is possible to observe that the most severe damages occurred to the granite cladding, which has a specific support configuration as indicated in Fig. 14. It is very interesting to note that the pressure distribution diagrams of the building façades, obtained from the wind tunnel study, show a direct correspondence to the damaged zones of the analysed full-scale buildings.
